Notes: 1. Do not s Key:	scale.
d by d.		OS Map
		Proposed footway edging
		Proposed footway resurfacing
		Grass
		Timber panel fence to be replaced
		Existing bin
		Proposed bin
		Bus shelter
	\bigcirc	Tree
		Feeder pillar (electrical access for street lighting)
		Existing steel knee rail (low level barrier)
		Replacement knee rail to match existing
7	P01.1 14/04/21 Rev Rev. Date	
	Rev Rev. Date	Apprv'd Jacobs 7th Floor, 2 Colmore Square, 38 Colmore Circus Queensway, Birmingham, B4 6BN Tel:+44(0)121 237 4000 www.jacobs.com
		Birmingham City Council
	CWG PUBLIC REALM IMPROVEMENTS	
	PERSHORE ROAD OUTSIDE CRICKET GROUND GENERAL ARRANGEMENT

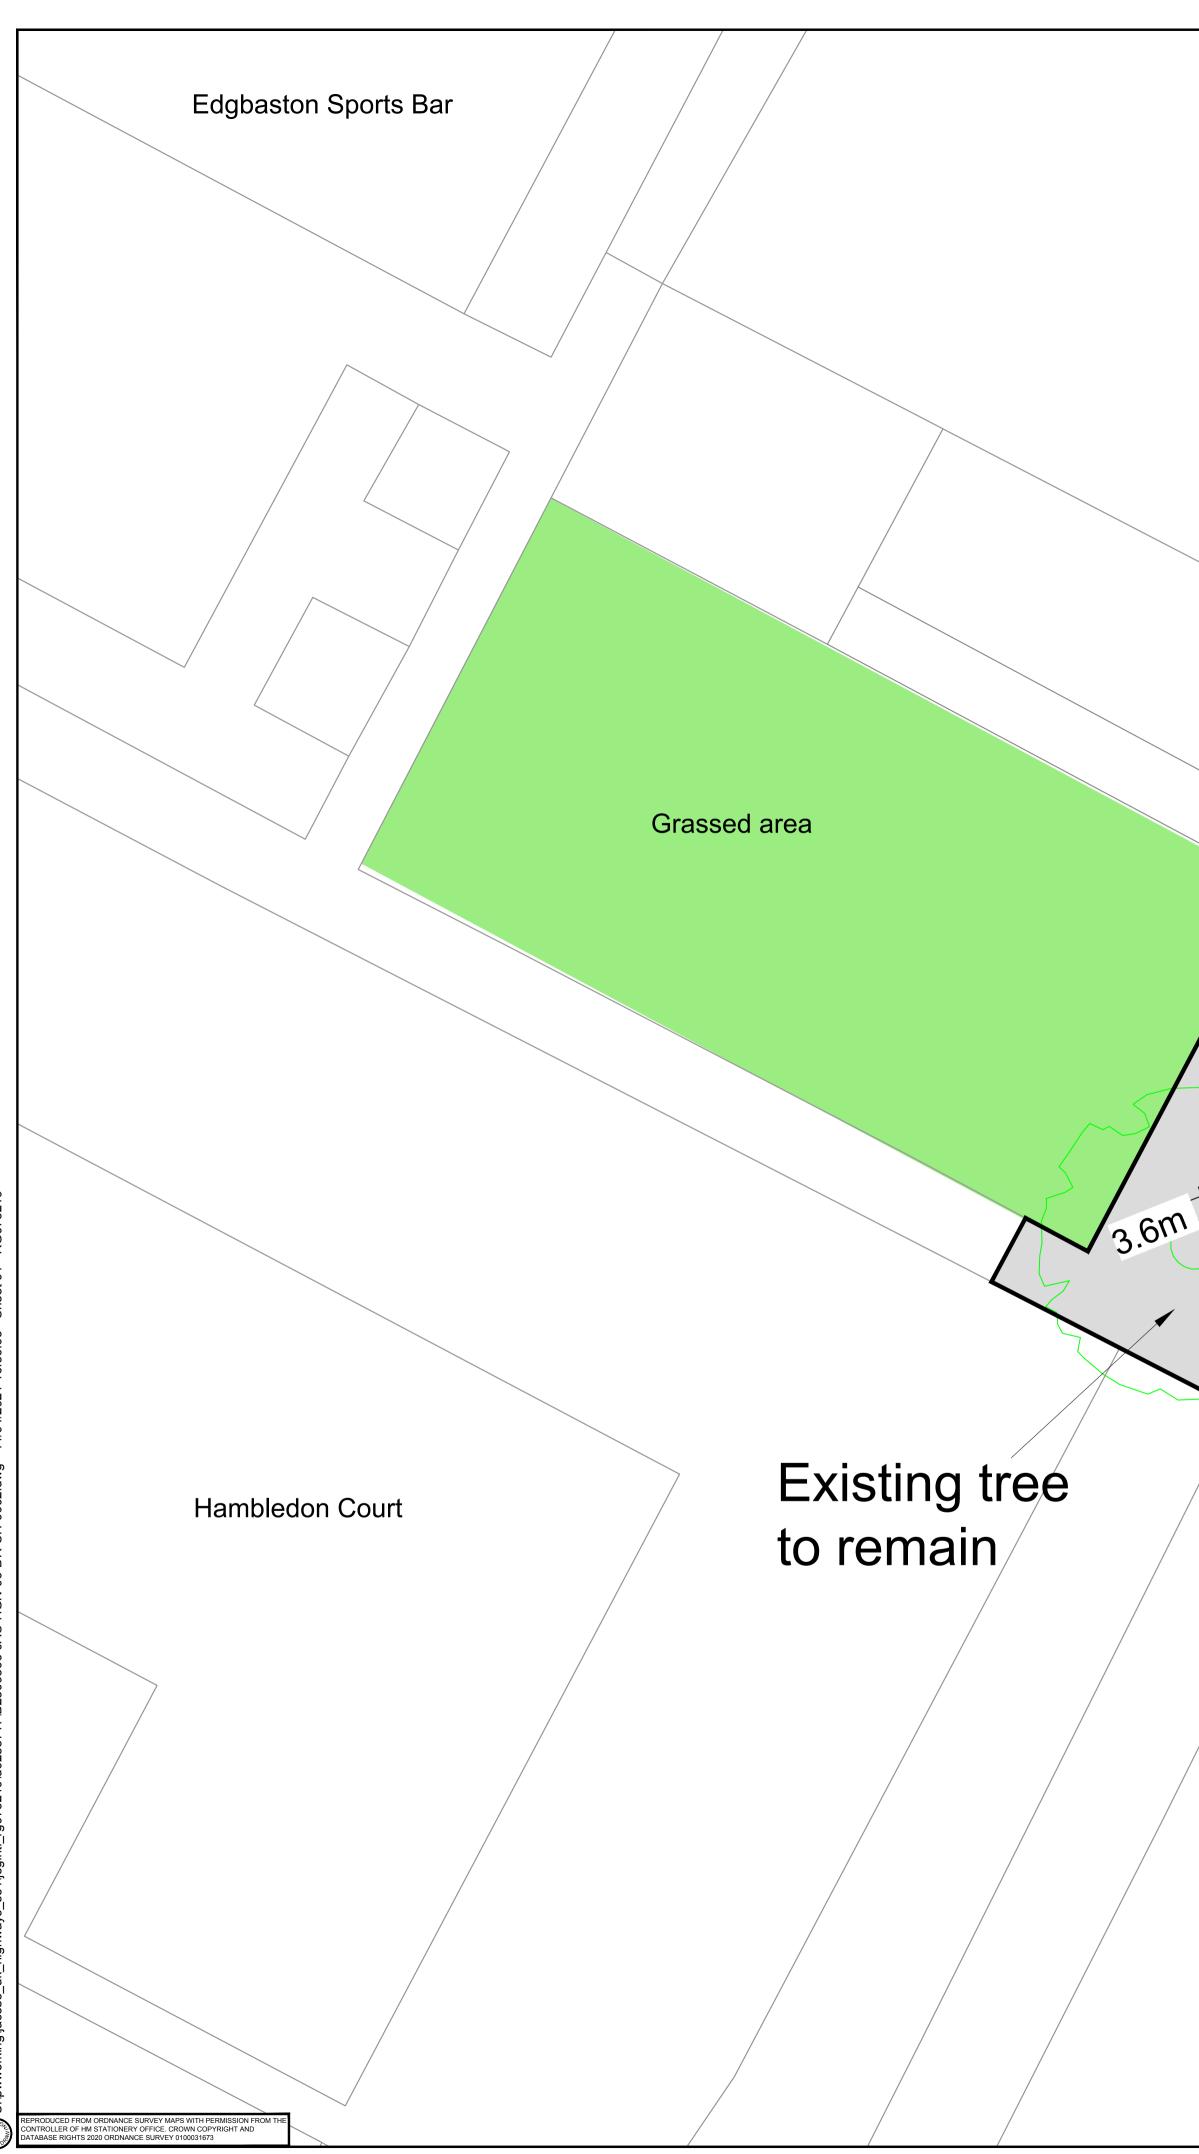
The footway behind the bus shelter on Pershore Road, which has been damaged tree roots, will be repaired and resurfaced.

Existing bin to be moved

Existing bus shelter to remain

Cricket ground entrances E8 & E9
